Cryogenic Storage Tank Non-Destructive Evaluation

Ellen Arens

Applied Physics Lab, Kennedy Space Center

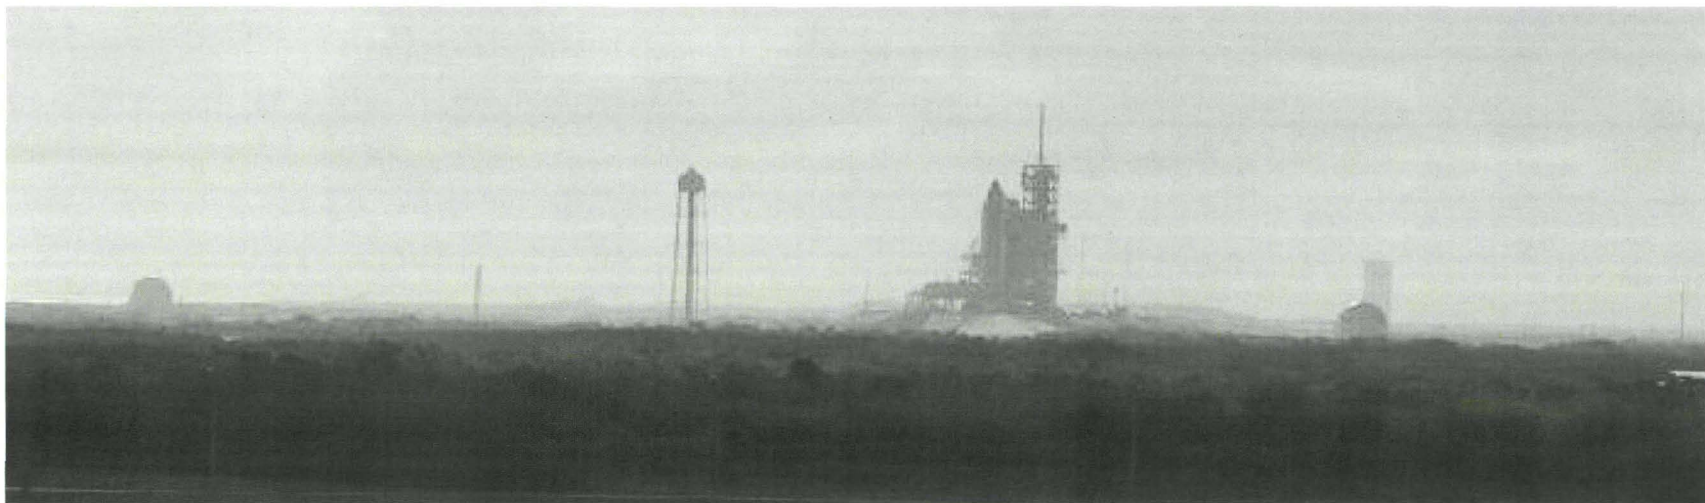
Included in the launch infrastructure at Kennedy Space Center are four large cryogenic tanks

- 1965 vintage, double-walled, spherical tanks with perlite insulation in the annular regions
- Two 850 kgallon LH2, Two 900 kgallon LO2
- Limited thermal life cycles

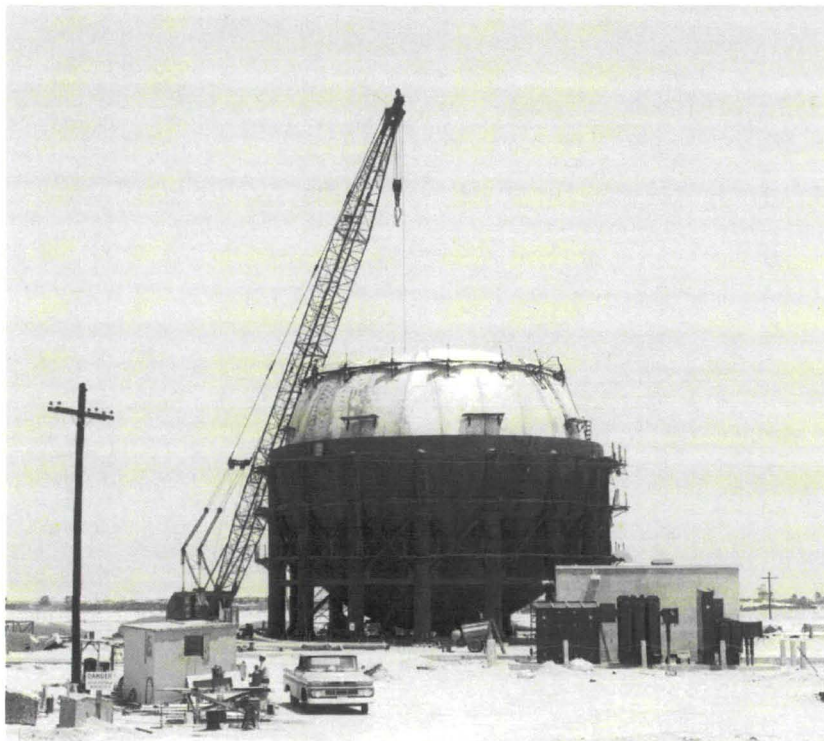
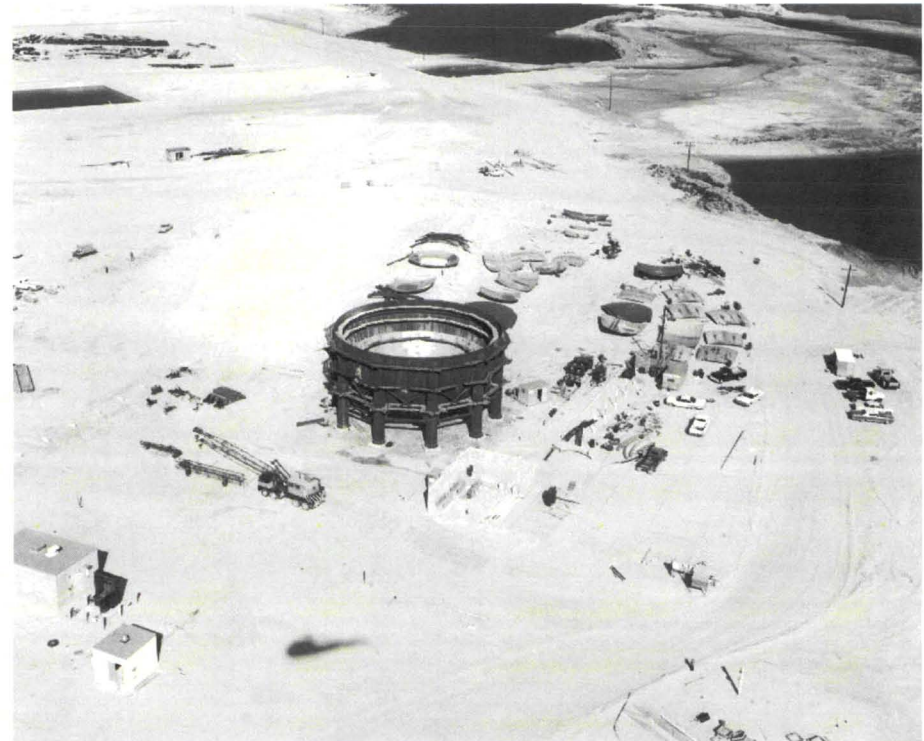
LOX Tank

- 900 thousand gallon, double-walled, spherical tank
- Constructed in 1965
- Annular region filled with Perlite insulation and under slight nitrogen purge
- Inner tank supported by 165 tie rods
- Outer tank diameter is 69 feet, inner tank diameter is 63 feet

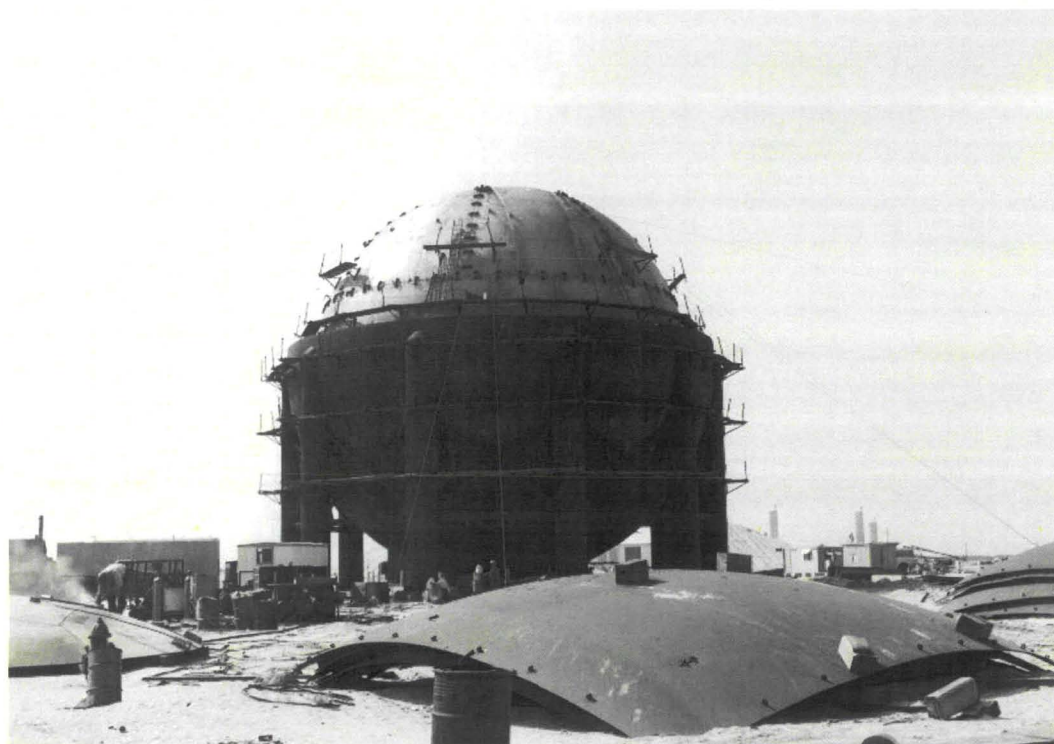
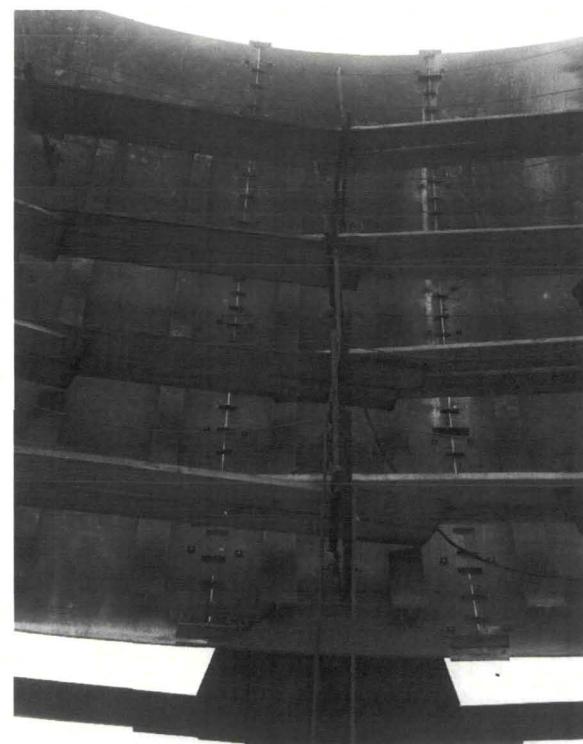
LH2 Tank

- 850 thousand gallon, double-walled, spherical tank
- Constructed in 1965
- Annular region filled with Perlite insulation and under vacuum
- Inner tank supported by 40 tie rods
- Outer tank reinforced with shell stiffeners
- Outer tank diameter is 70 feet, inner tank diameter is 31 ½ feet

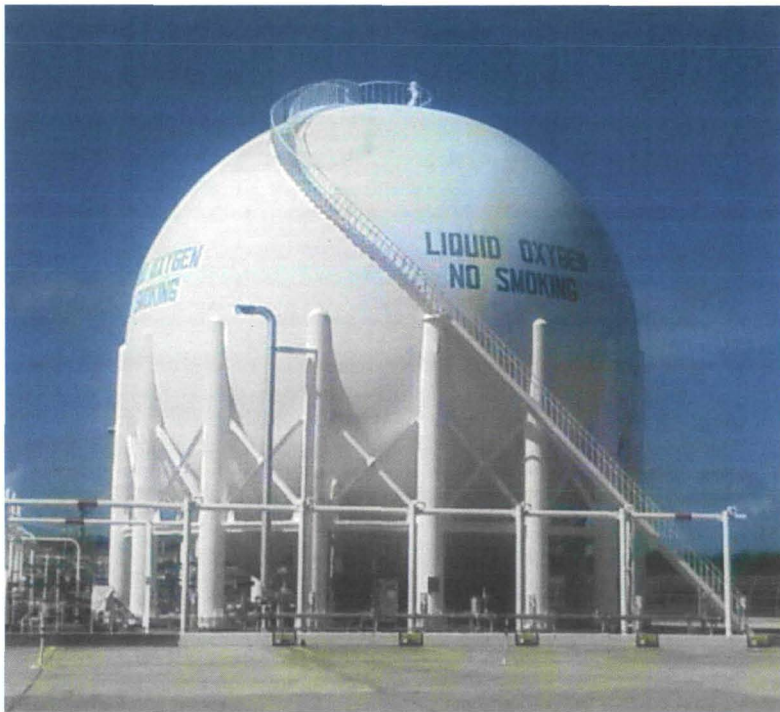
Concerns for Pad A LO2

- History of Perlite settling
- Slight discoloration in localized area on the tank
- Slight increase in boil-off compared to equivalent Pad B tank

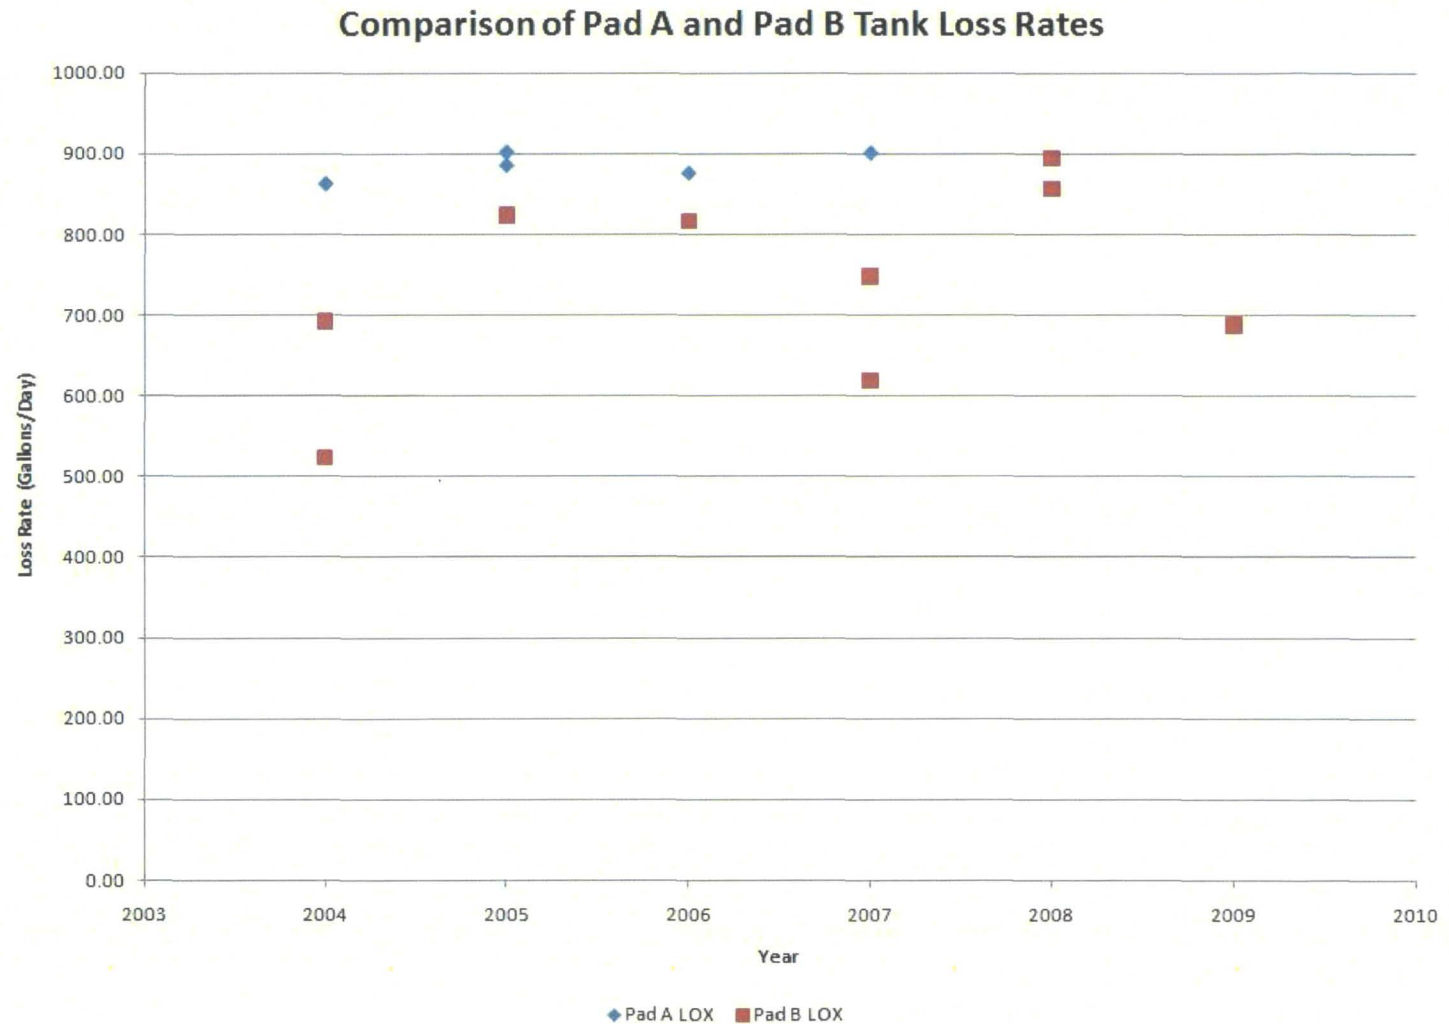
Cryogenic Storage Tank NDE- LO2 Loss Rate Comparison

- **Pad A LOX Tank Loss Rate**
 - Average 800-900 gallons per day
 - Not dependent on fill level
- **Pad B LOX Tank Loss Rate**
 - Average 600-800 gallons per day
 - Not dependent on fill level

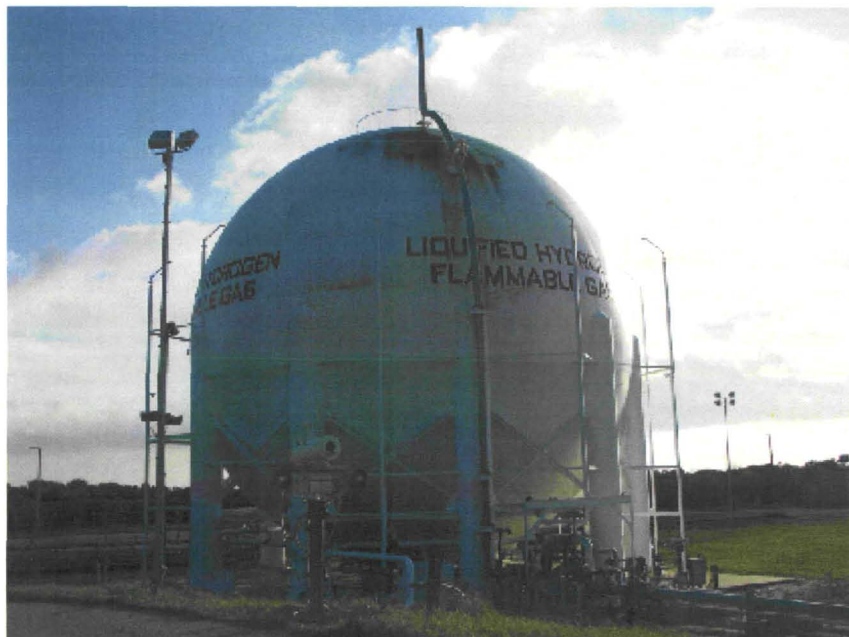
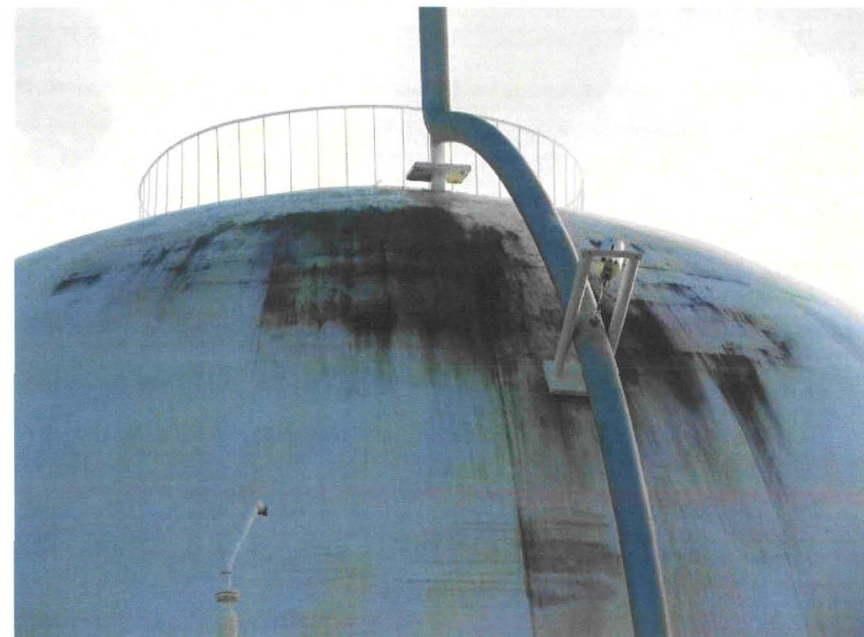
Concerns for Pad B LH2

- Pad B LH2 Tank has an significantly higher boil-off rate than the Pad A LH2 tank
- Visible indication of increased heat flow via mold growth
- Long down-time needed for repairs
- 3 of 5 full thermal cycles have been used on the Pad B LH2 tank

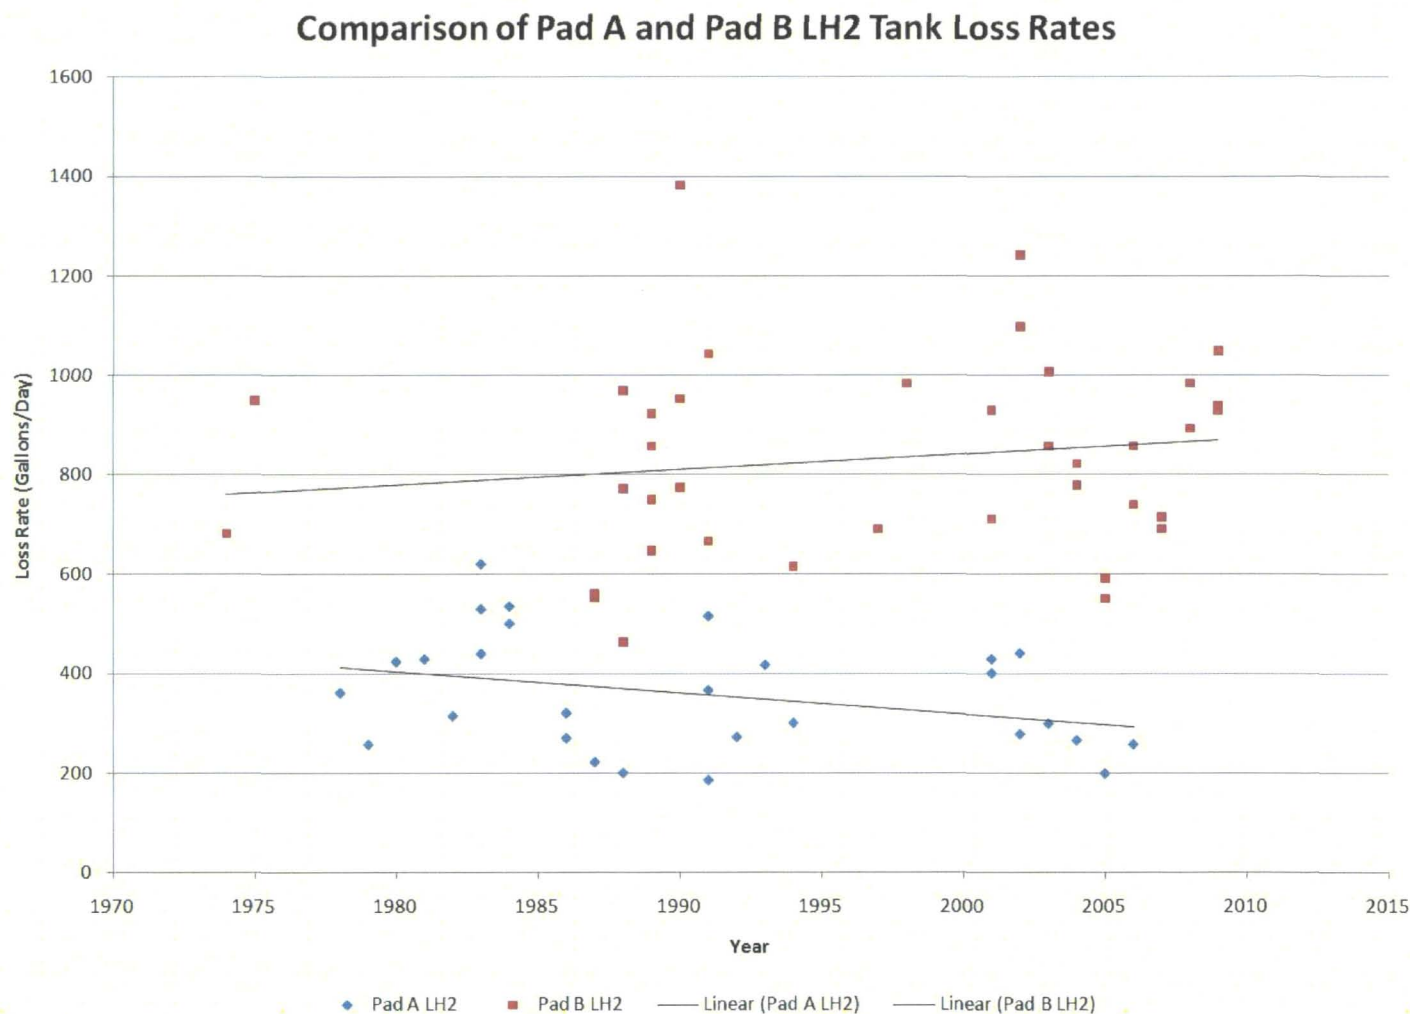
Cryogenic Storage Tank NDE- LH2 Loss Rate Comparison

- **Pad A LH2 Tank Loss Rate**
 - Average less than 400 gallons per day
 - Not dependent on fill level
- **Pad B LH2 Tank Loss Rate**
 - Between 600 and 1200 Gallons per day
 - Dependent on fill level of the tank

Modeling of heat transfer has shown that fill level dependence of the Pad B LH2 loss rate is likely due to an insulation void near the top of the tank and not to any structural defect.

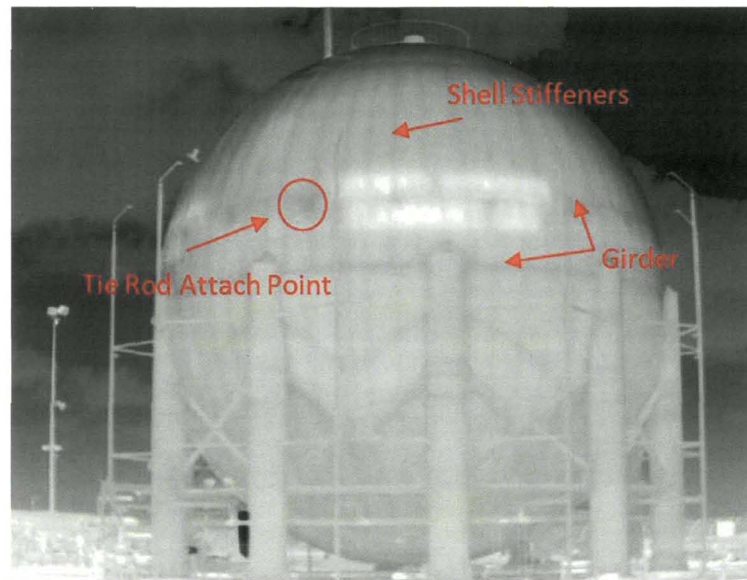
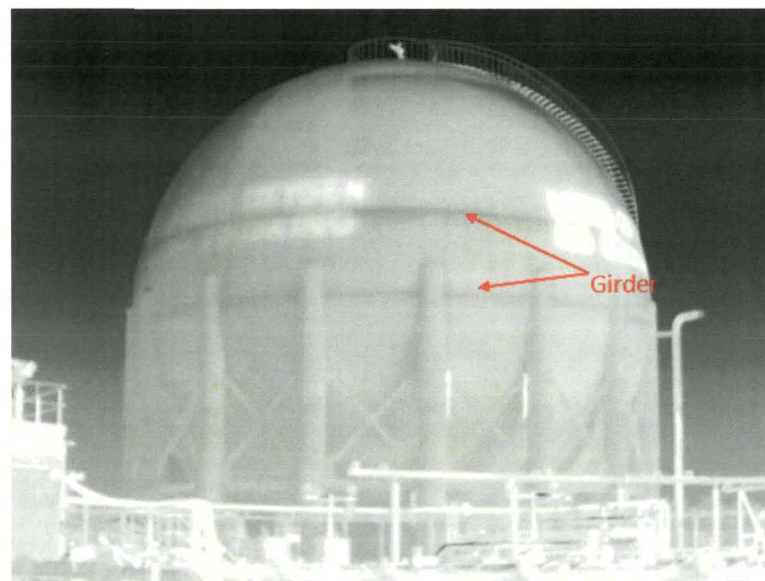
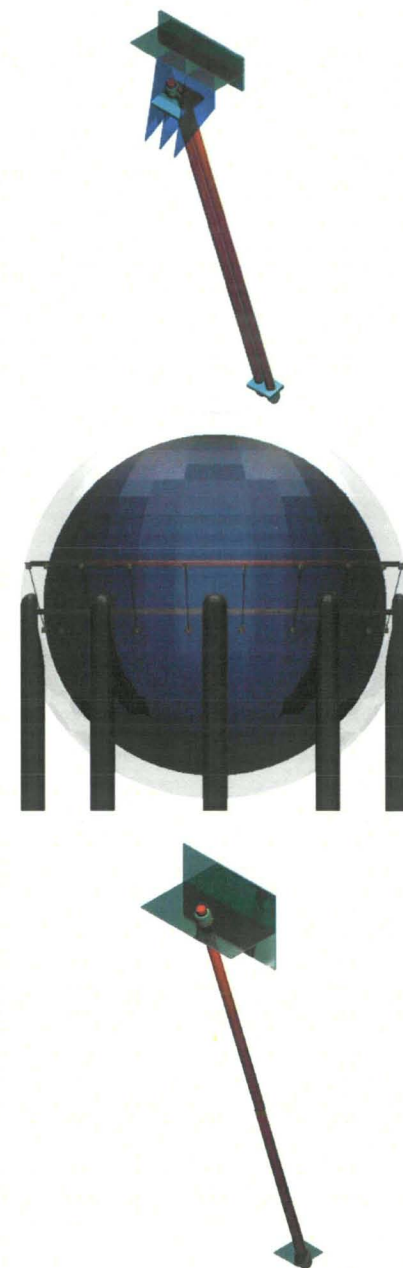
Structural Elements

- Tie rods attach outer sphere to inner sphere
- LH2 40 rods at 20 attach points
- LOX tank has 165 evenly spaced
- Both tanks have stiffeners running from the upper girder to equatorial girder
- LH2 tank has stiffeners throughout the structure due to the vacuum in the annular region

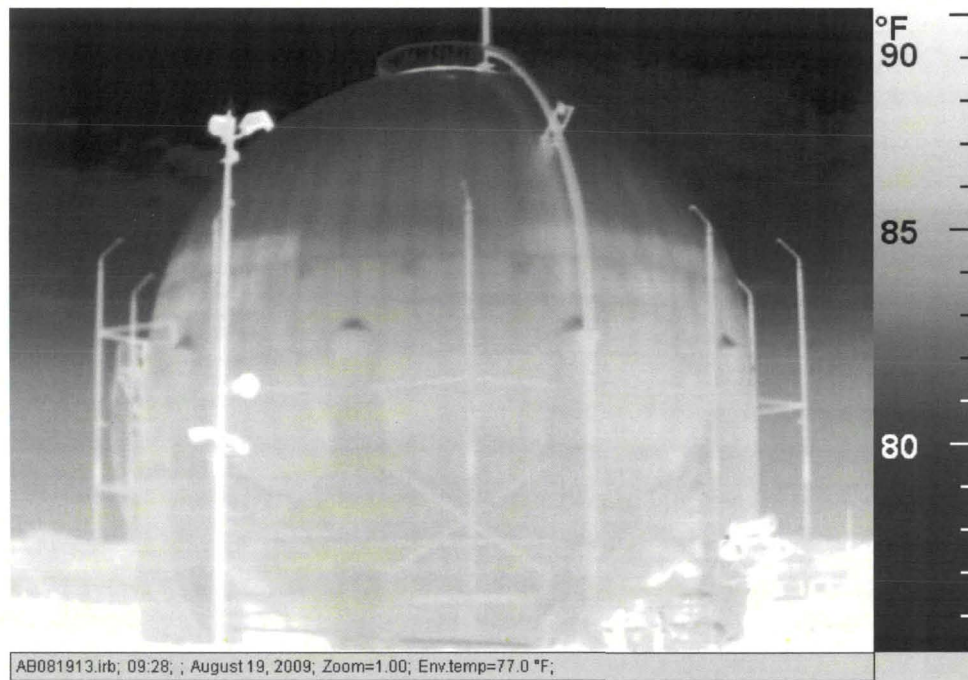
Pad A LH2

- Thermal imaging confirms that there is a significant difference between the Pad A and B LH2 tanks
- Probable cause of “cold spot” on Pad B LH2 tank is missing perlite

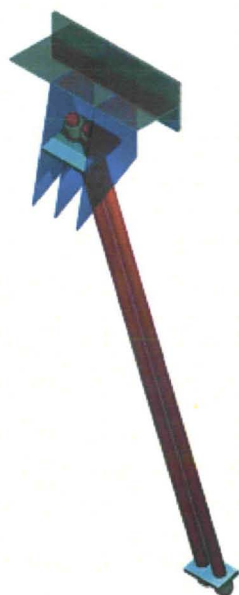
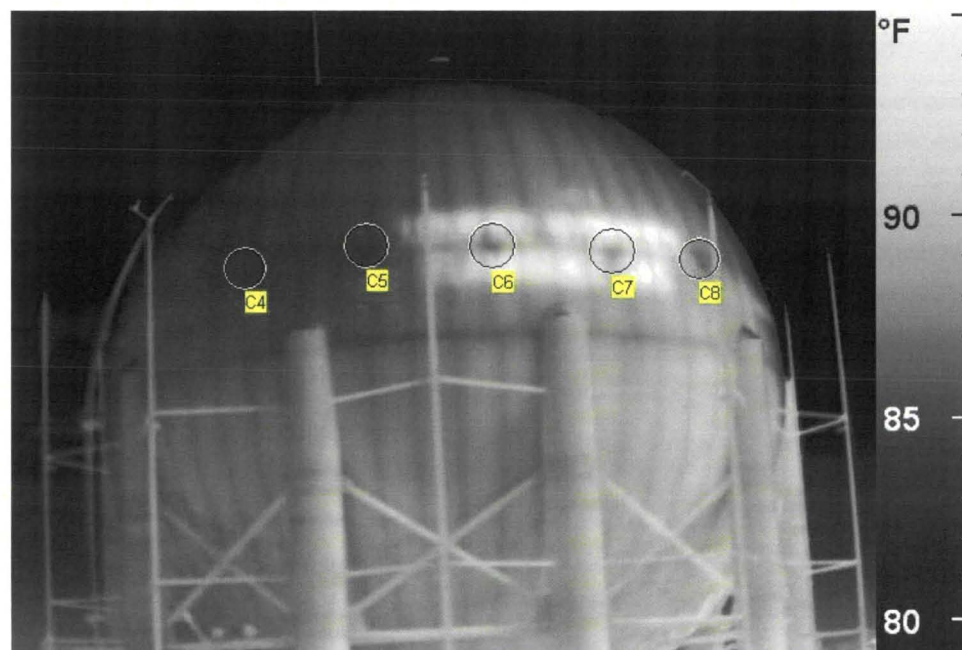
- Images were taken from all directions of the Pad A and B LH2 tanks to locate the tie rod attach points
- All twenty locations were noted in images for Pad A and B tanks (2 rods at each location for 40 rods total)
- The heat loss down the rods to the inner tank is small compared to the total heat entering the system, it would be difficult to tell through thermal analysis alone if the tie rods are attached to the inner sphere due to variations such as sun angle, wind speed, and paint emissivity

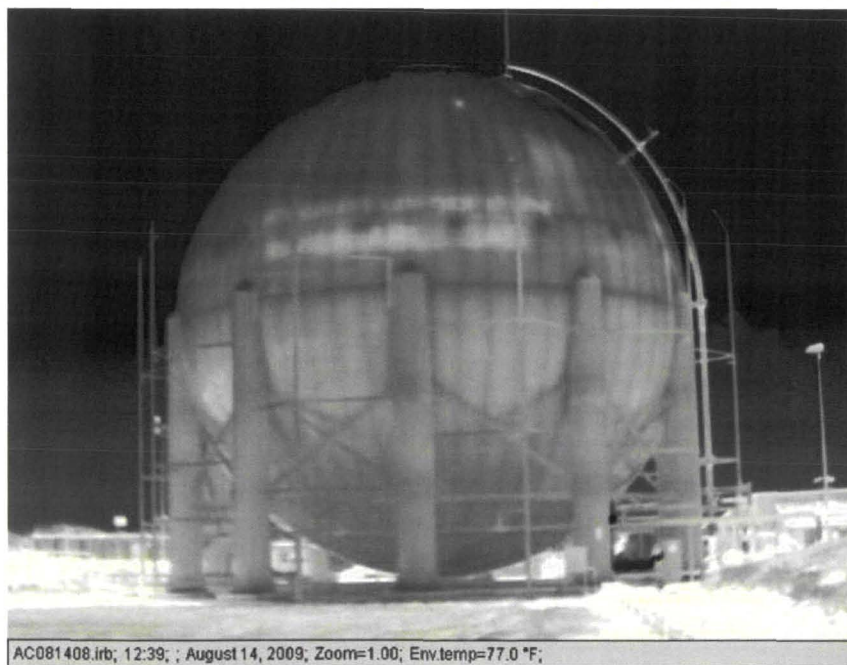
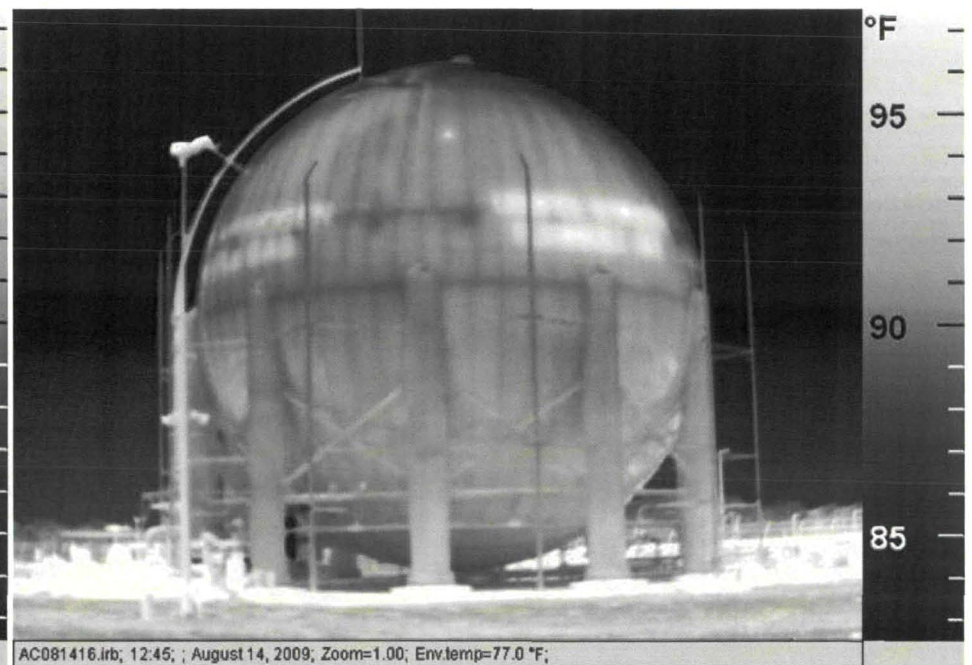
- Pad B LH2
- Images were taken at 12:30 pm on 8-14-09
- Indication of cold region near vent line on upper hemisphere, no other cold regions noted

Future – Perform thermal imaging on tanks prior to filling to look for insulation anomalies

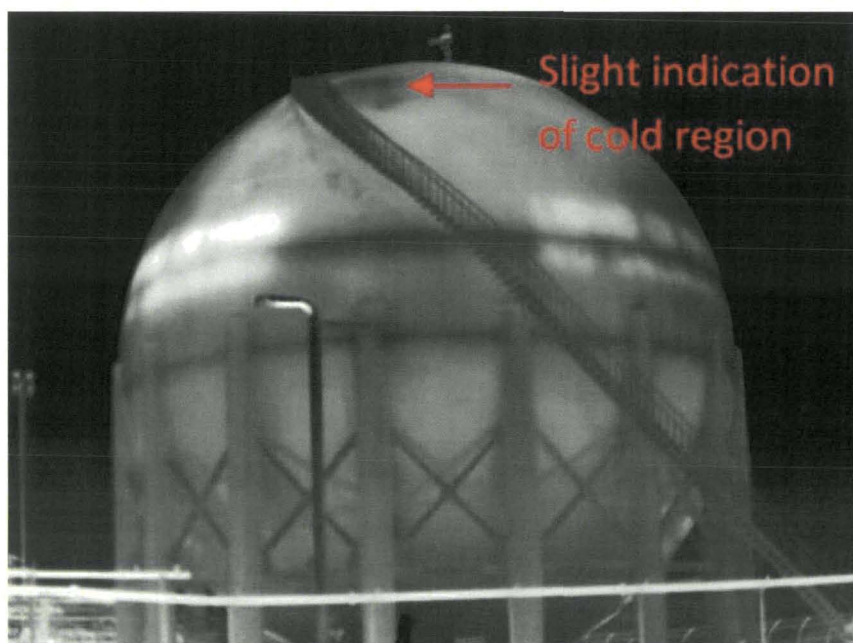
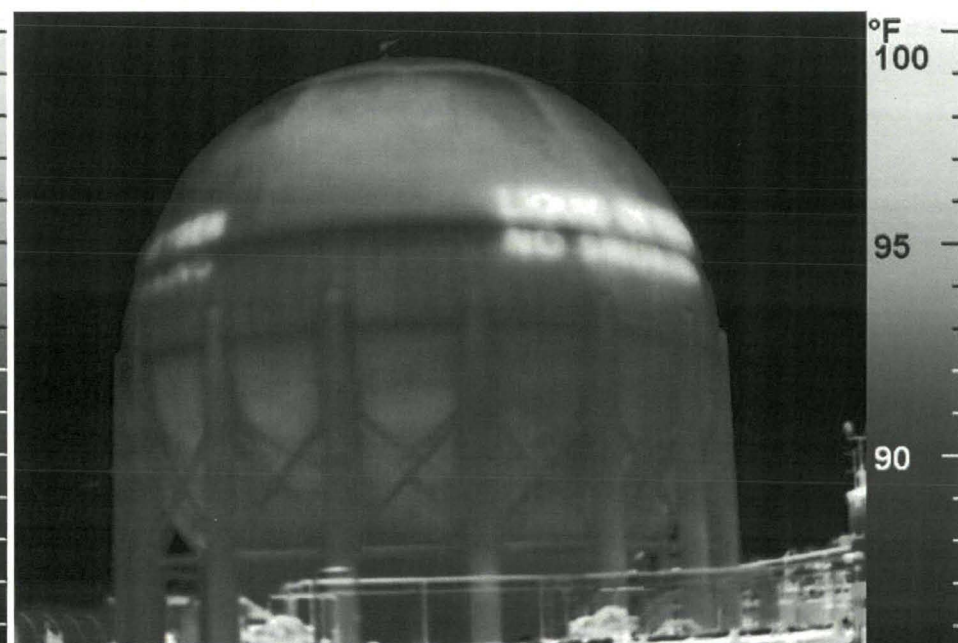
- Pad B LOX
- Images were taken at 1:00 pm on 8-14-09
- Slight indication of a cold region above staircase on upper hemisphere

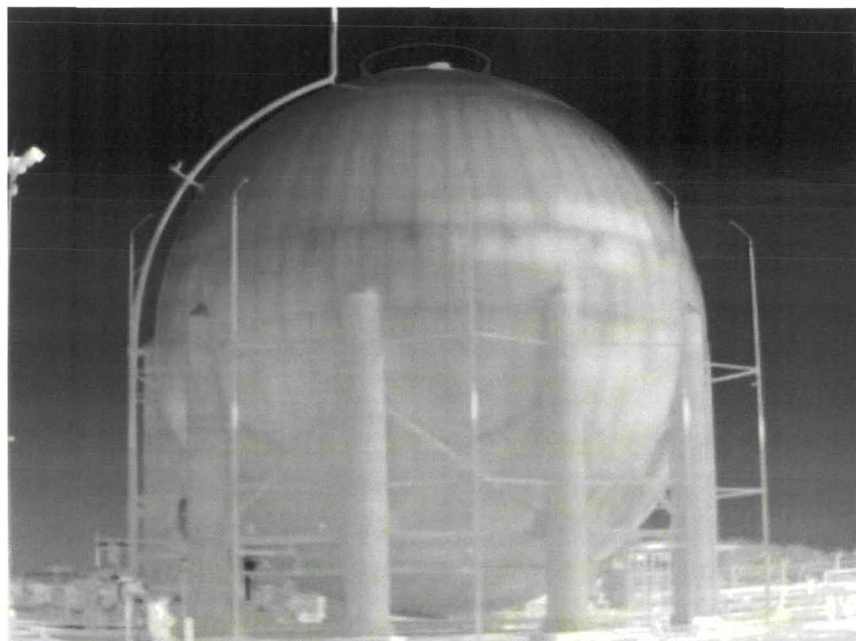
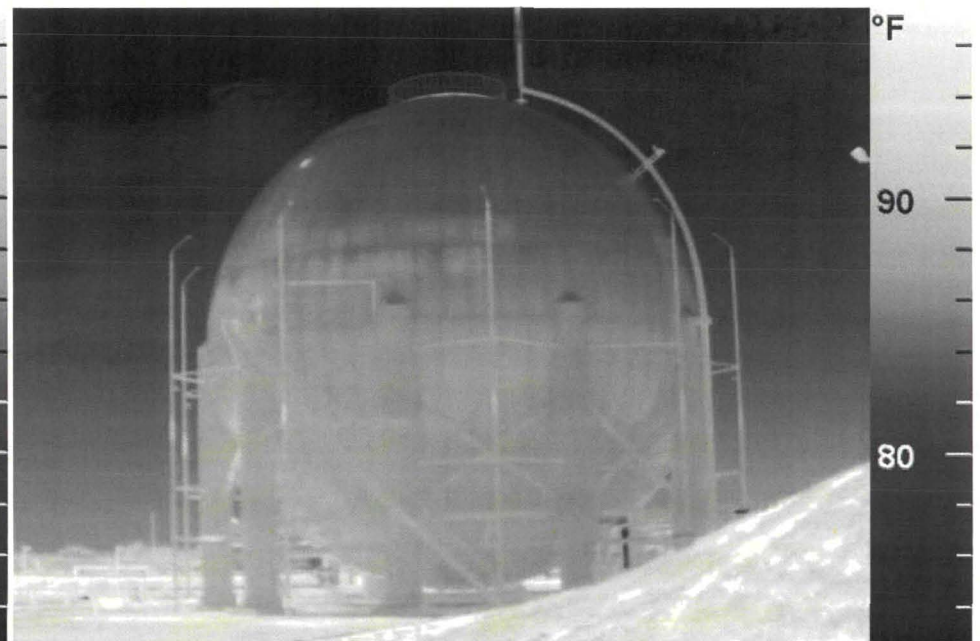
- Pad A LH2
- Images were taken at 9:30 am on 8-19-09
- No indications of cold regions on this tank

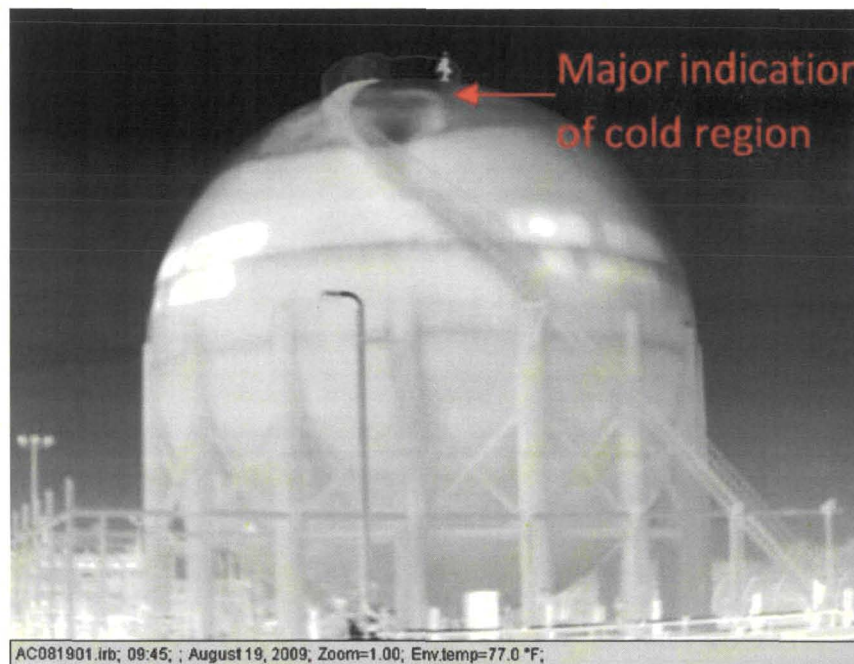
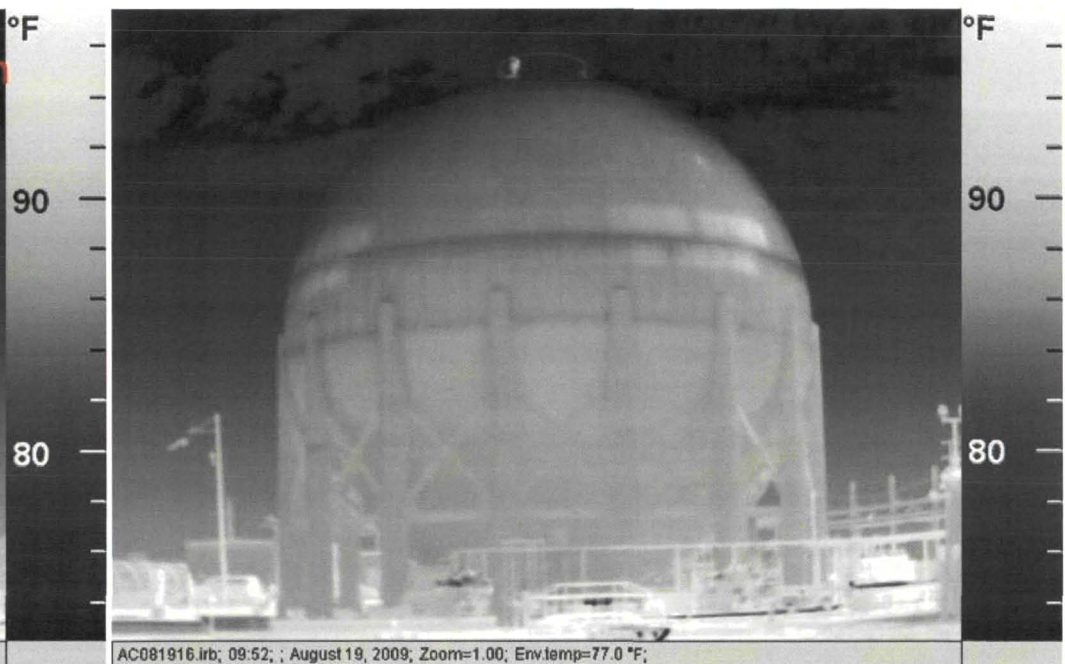
- Pad A LOX
- Images were taken at 9:45 on 8-19-09
- Definite indication of a cold region above staircase on upper hemisphere, thermal image shows region that is significantly larger than discolored area on sphere indicates; could be due to perlite compaction and settling

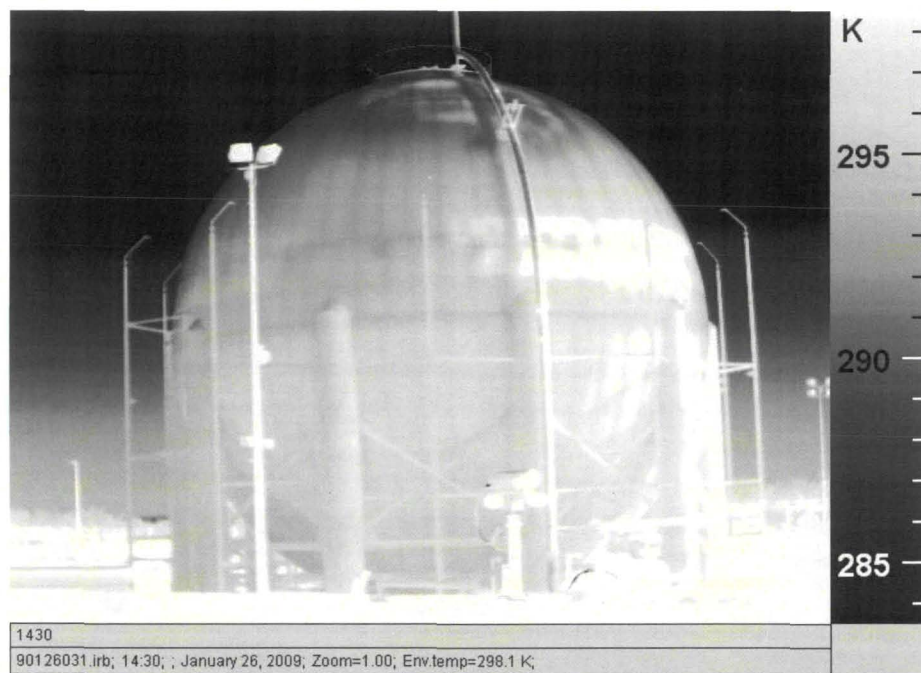
- Thermal images can be significantly effected by environmental conditions, shown below are image differences on similar days but with different wind speeds. Other effects that were considered include ambient temperature, humidity levels/dew, cloud reflections

- 1-26-09, 2:30 pm
- 68°F
- 67% RH
- Wind Speed 8 mph

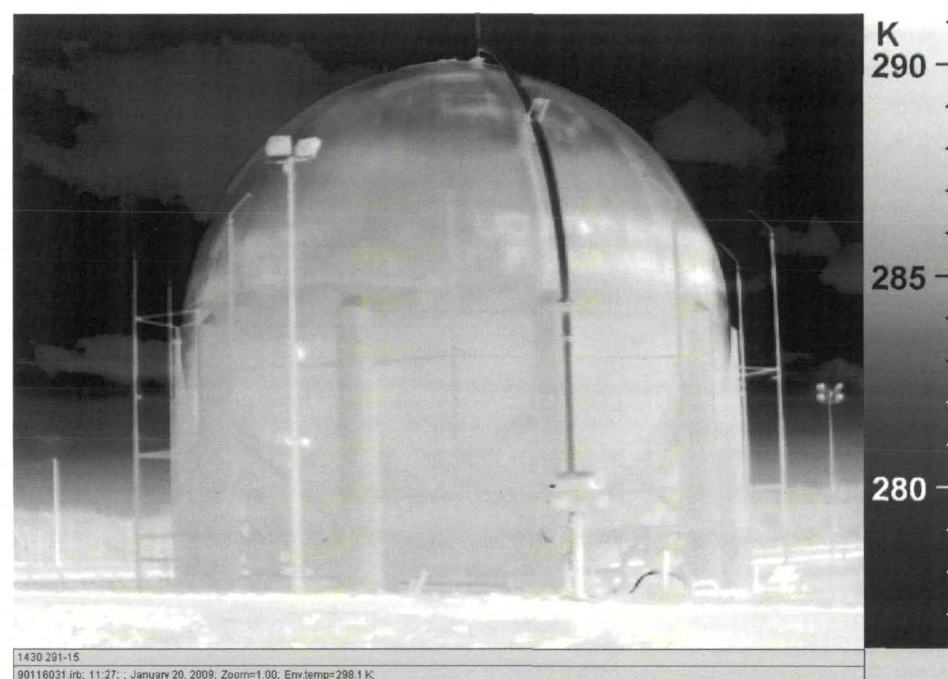
- 1-16-09, 2:30 pm
- 56°F
- 65% RH
- Wind speed 21 mph
